På jakt etter den ukjente vannkvalitet: pressfaktorer, tilstand og integrert vannressursforvaltning i Myanmar

Tor Erik Eriksen, Phyo Wai, Phyo Thet, Andreas
Ballot, Ingrid Nesheim & Nikolai Friberg
Norwegian Institute for Water Research, NIVA

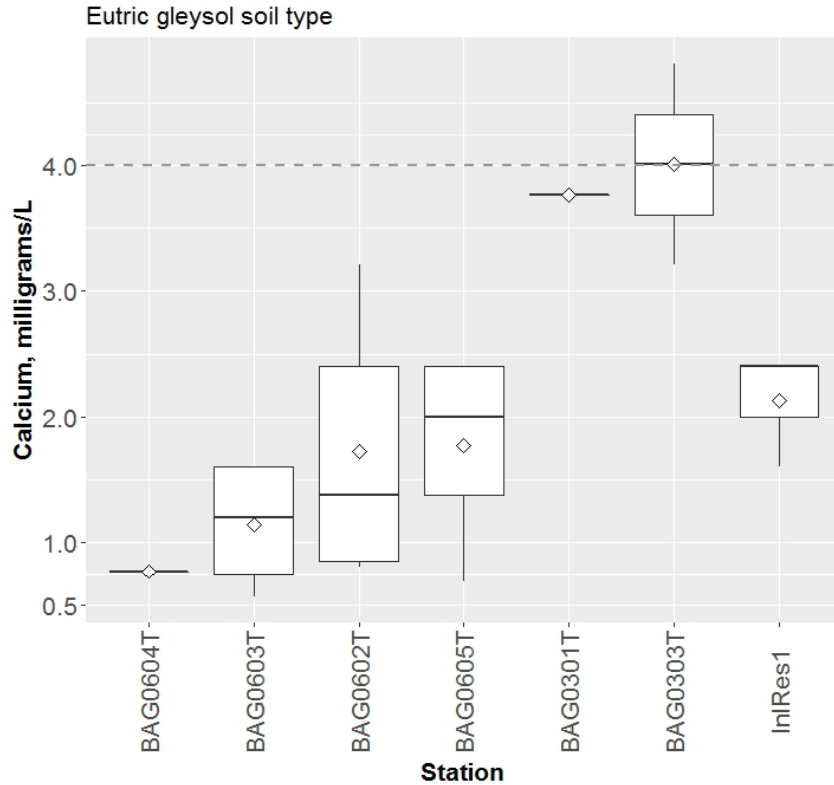
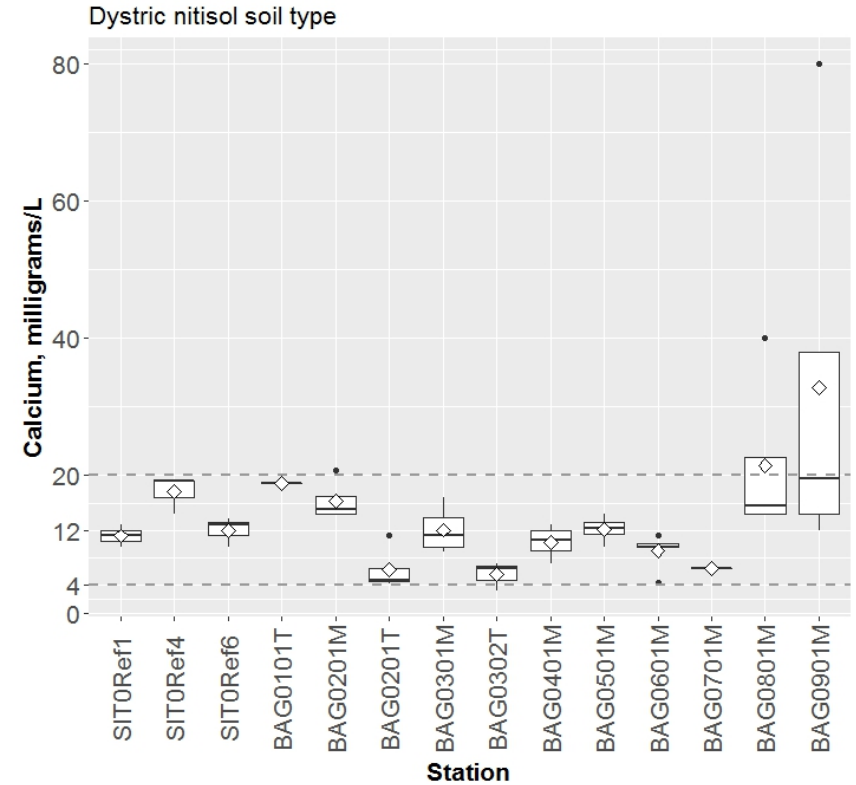
Soil types mirror water chemistry

- supports the water body division

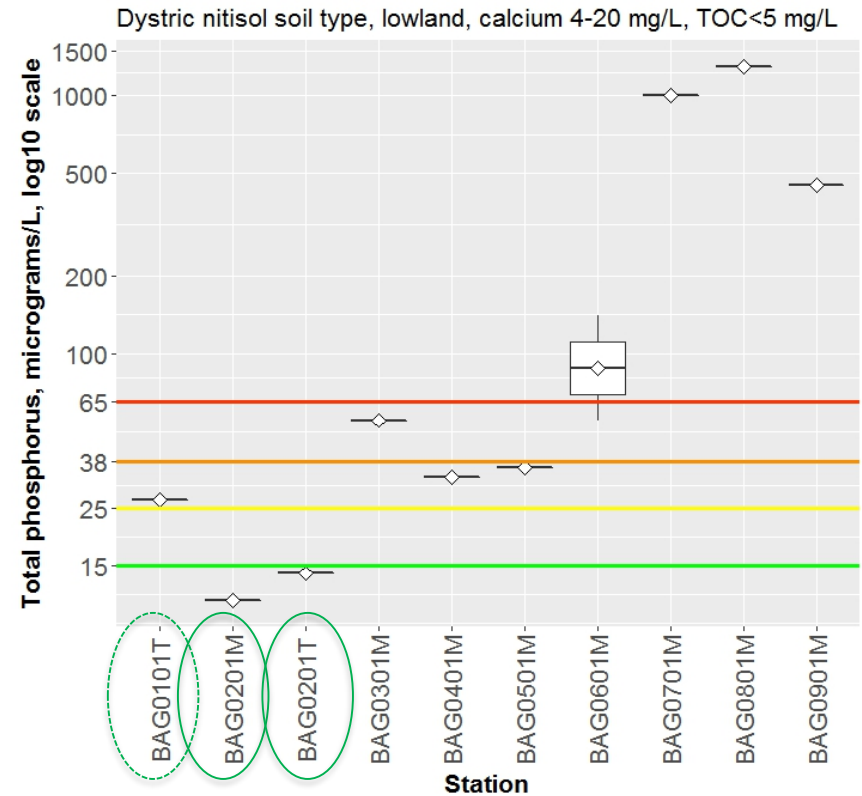
Preliminary results for nutrients

- We try to cover a gradient of P-pollution. Norwegian class boundaries for total P are shown.

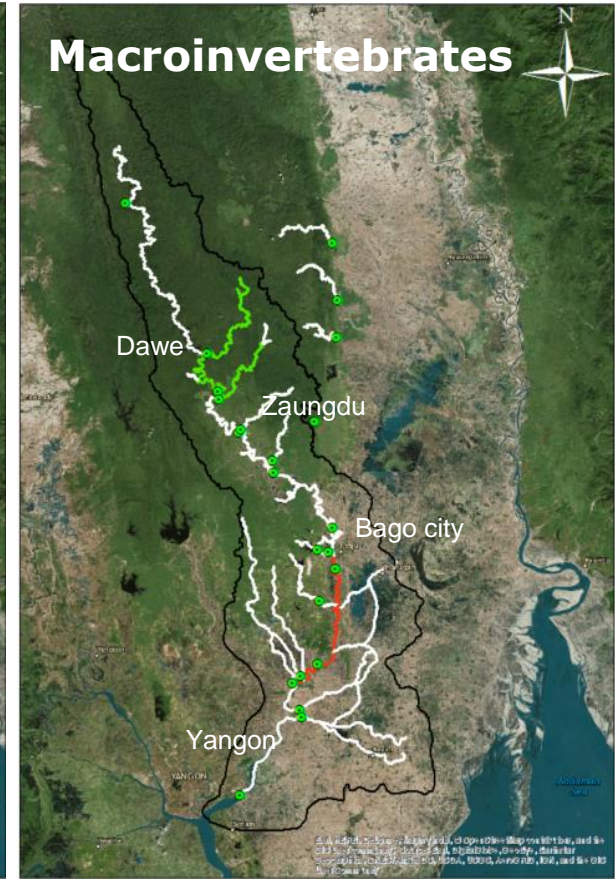
Preliminary results – signs of nutrients/organic pollution.

Ammonia (NH_4^+) is a gas that is produced by bacteria and animals when they decompose organic matter.

Phosphate ($\text{PO}_4\text{-P}$) may enter the river from sewage (toilets), agricultural fields (fertiliser) and animals.

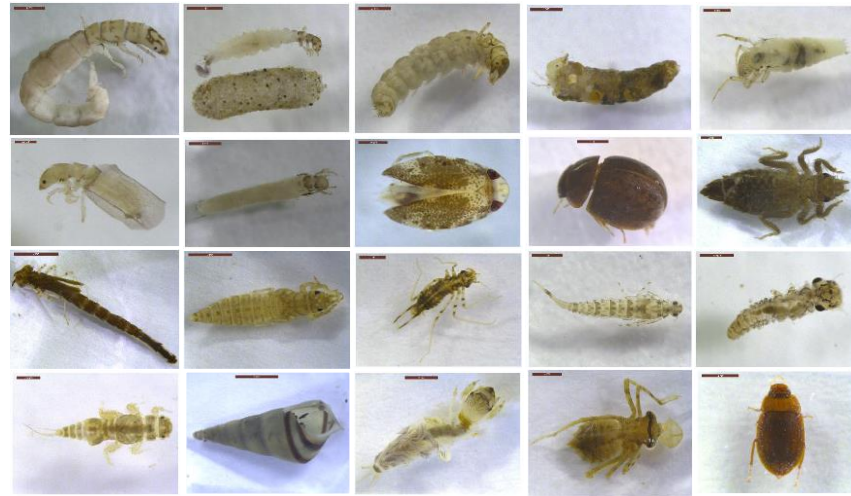
Low P sites are diverse

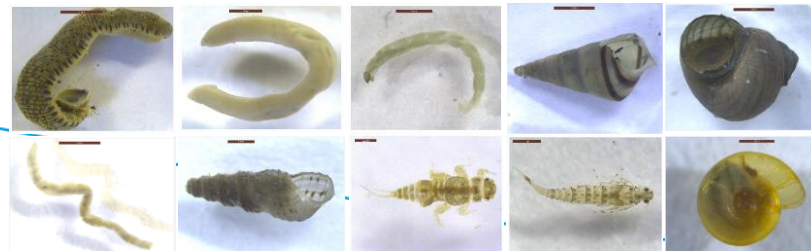
High P sites have fewer and tolerant taxa

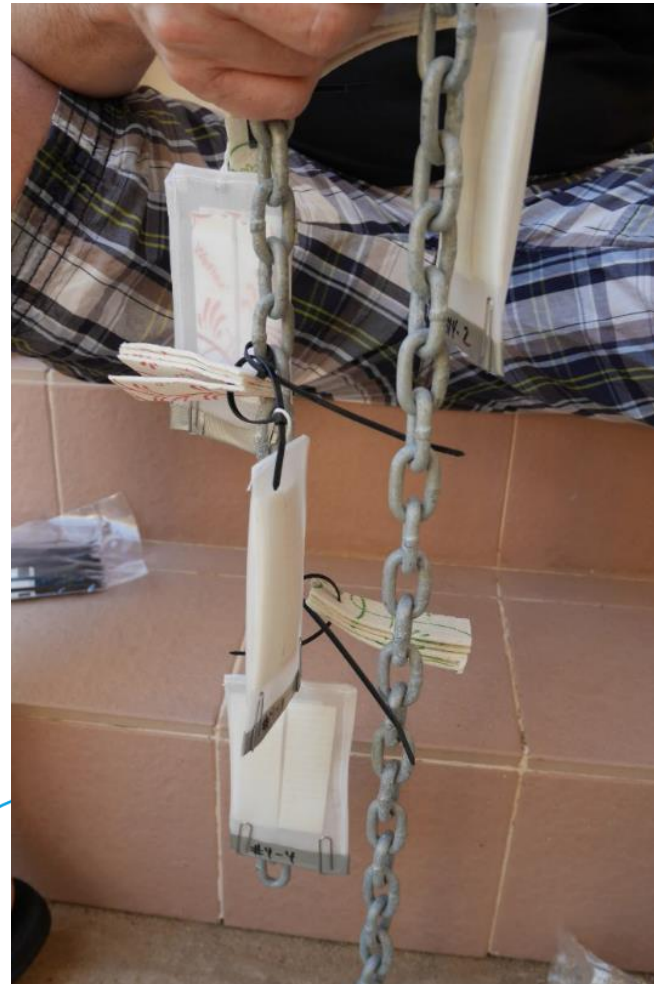
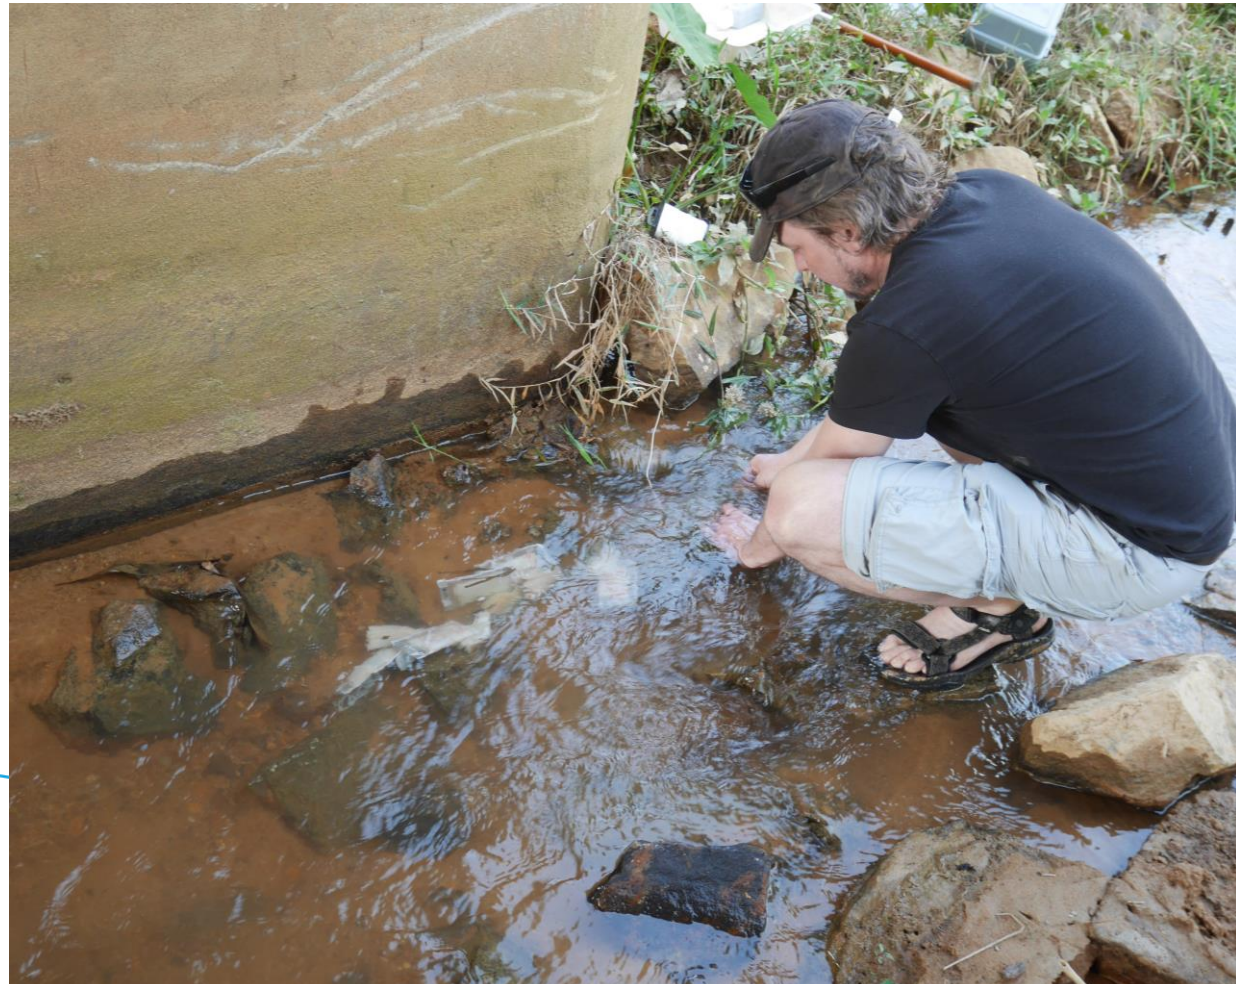
Leaf packs breakdown experiment - integrates biochemical activity over time

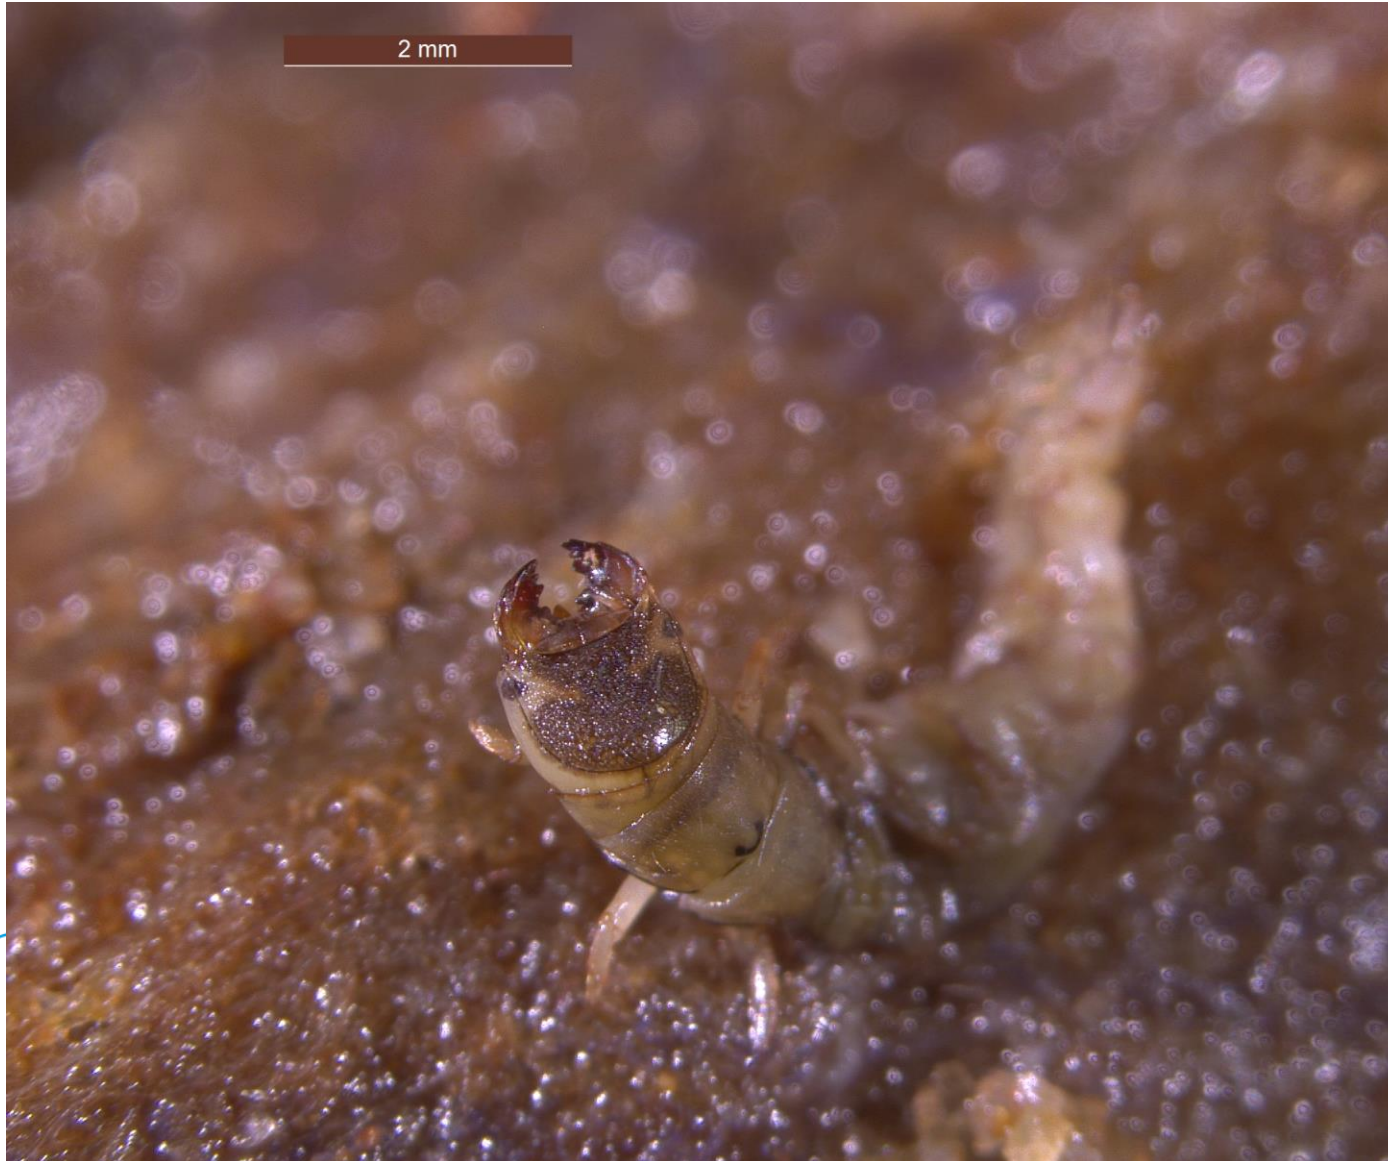
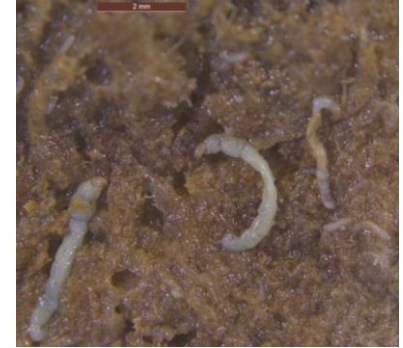
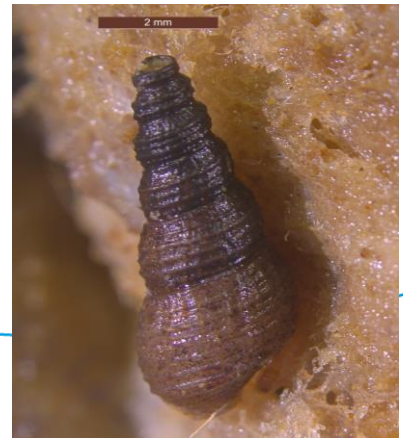
Leaf pack colonizers

- we see higher breakdown rates in smelly places
